Title: 2013 Sanitary Sewer Evaluation Study Final Report

Attachment 2
2013 Sanitary Sewer Evaluation Study Final Report

Village of Winnetka, Illinois

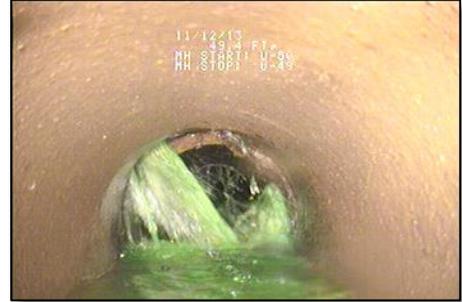
Dyed Water Inflow

In those areas where dyed-water enters the sanitary sewer line or where it is suspected that sewer sections under waterways may allow I/I to enter the system, a television inspection is performed in conjunction with dye-testing. The inspection equipment consists of a closed circuit television camera that is passed through the sewer for the purposes of locating and identifying I/I source(s) and observing the condition of the pipe. The following photo provides a visual of an inflow source found from dyed-water testing.
